# Capitol Square Landscape Master Plan

Department of General Services  
Capitol Square Preservation Council

Rhodeside & Harwell, Incorporated

July, 2004

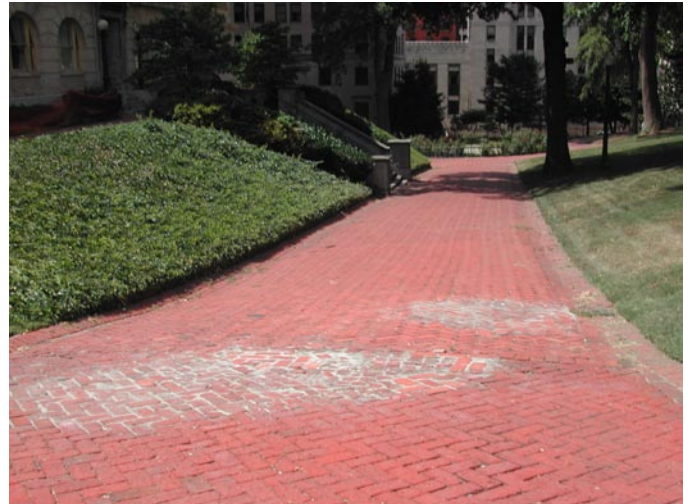
*Broken pavers at Governor's Walk*

The brick path at Governor's Walk is in extremely poor condition with deep depressions, broken pavers and damaged drainage inlets. Narrow brick service paths have been added near the base of the Capitol that clutter the landscape immediately around the building.

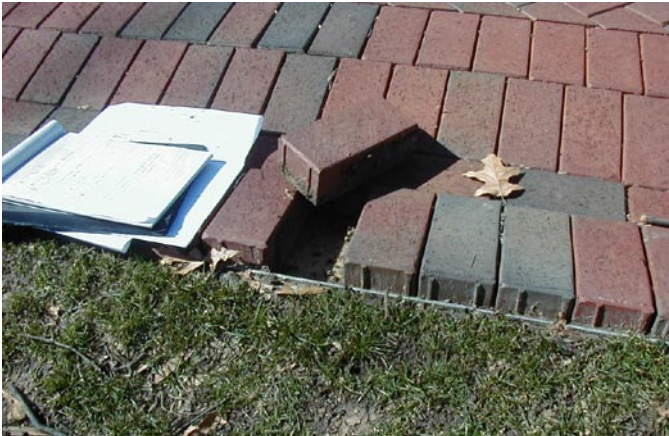
*Brick pavers with loose-set edge*

concrete base. The typical edge is one or more soldier courses set at an angle to form a shallow gutter. This is held in place with a steel edge that is staked in place. In many locations, the angled bricks are coming loose from the steel edge and pose a maintenance problem and a potential tripping hazard.

- *Establish a standard brick paving material, pattern and method of setting to be used for all future repairs and replacements.*
- *Reconstruct the loose-set edge of the modern pavers with a fixed edge.*

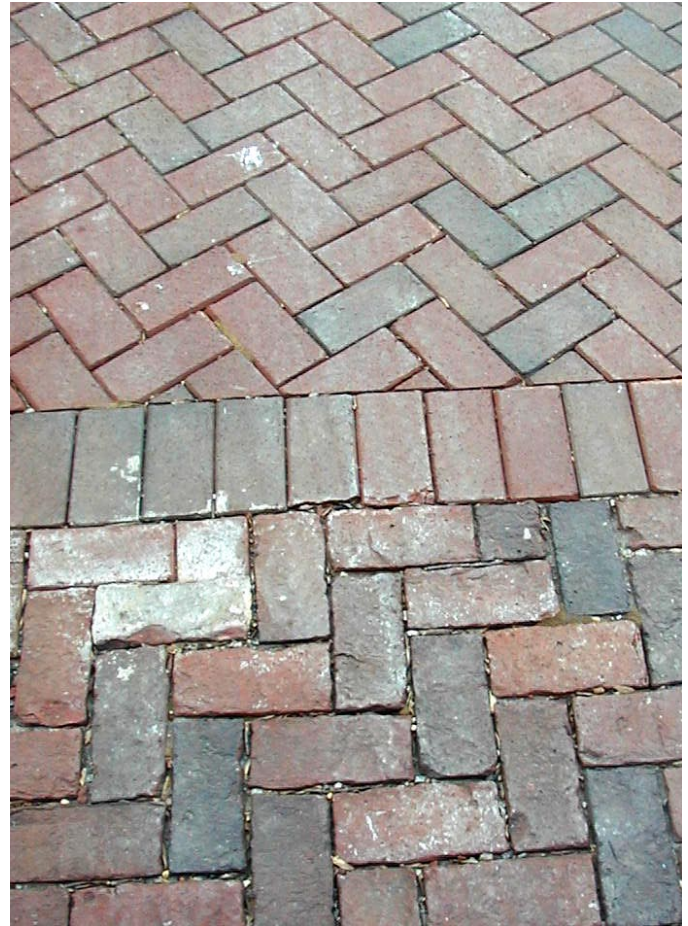
*Modern pavers above, original brick below*

The earliest record of brick installed on the Square is from the 1930's, with about half of the brick remaining on site from this period. It is a red clay brick installed in an orthogonal herringbone pattern with a single soldier course edge. This brick originally had grouted joints but the grout has since disappeared and weeds are now growing in the interstitial spaces. Much of this brick is damaged and will eventually require repointing or replacement. It's dark red color contrasts sharply with the light, neutral colors of the Capitol exterior.

About one third of the brick on site is modern and was installed within the last five years. This consists of a contemporary unit clay paver, set in a diagonal herringbone pattern with sand swept joints. The pavers themselves are loosely set on a sand bed over a

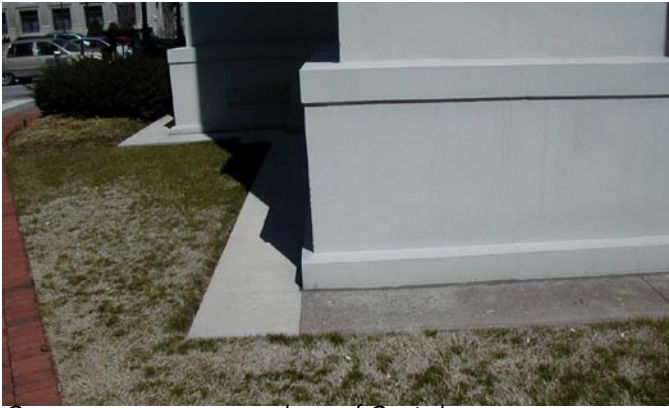
*Concrete spatter course at base of Capitol*

- *Replace the concrete spatter course around the Capitol with stone that will compliment the building.*
- *Modify northwest and northeast entry points to accommodate ADA compliance.*

3. Replace concrete spatter course with granite at base of building.

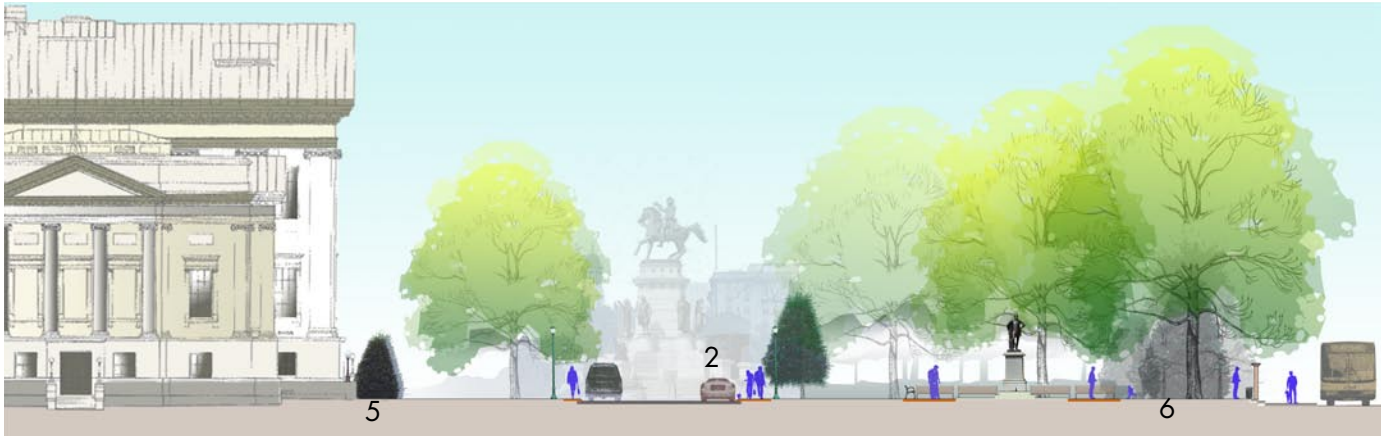
Cross Section North of Capitol - Existing Conditions

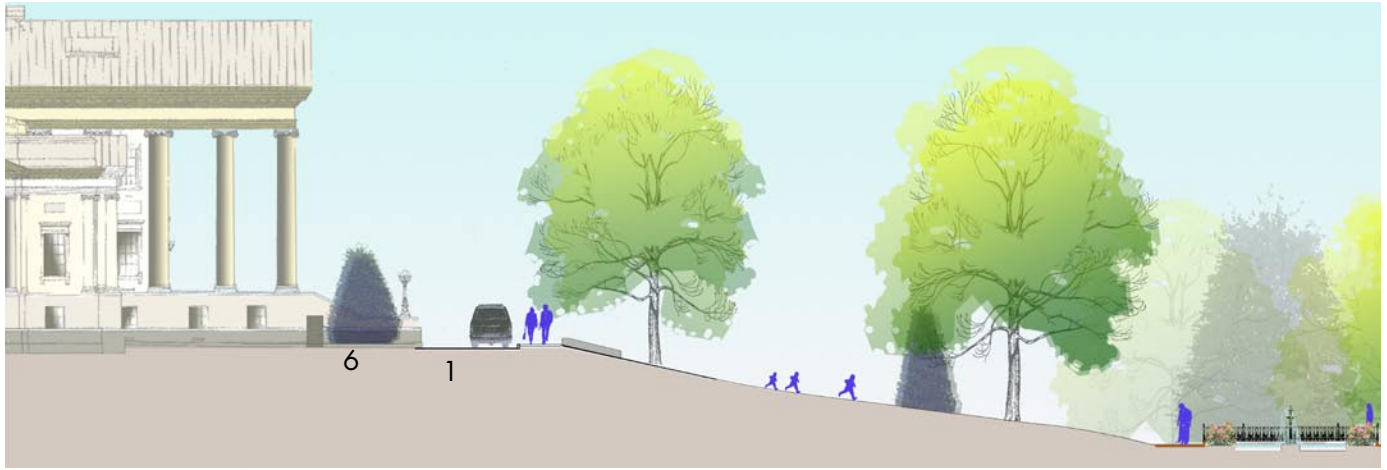
Cross Section South of Capitol - Existing Conditions

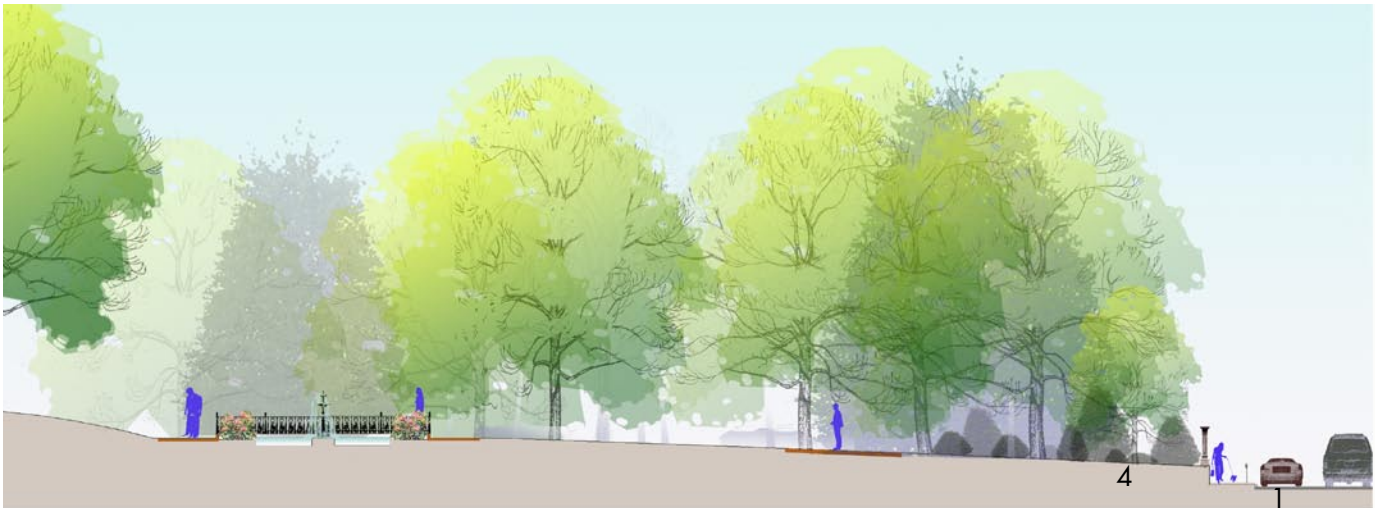
*Cross Section at Bank Street - Existing Conditions*

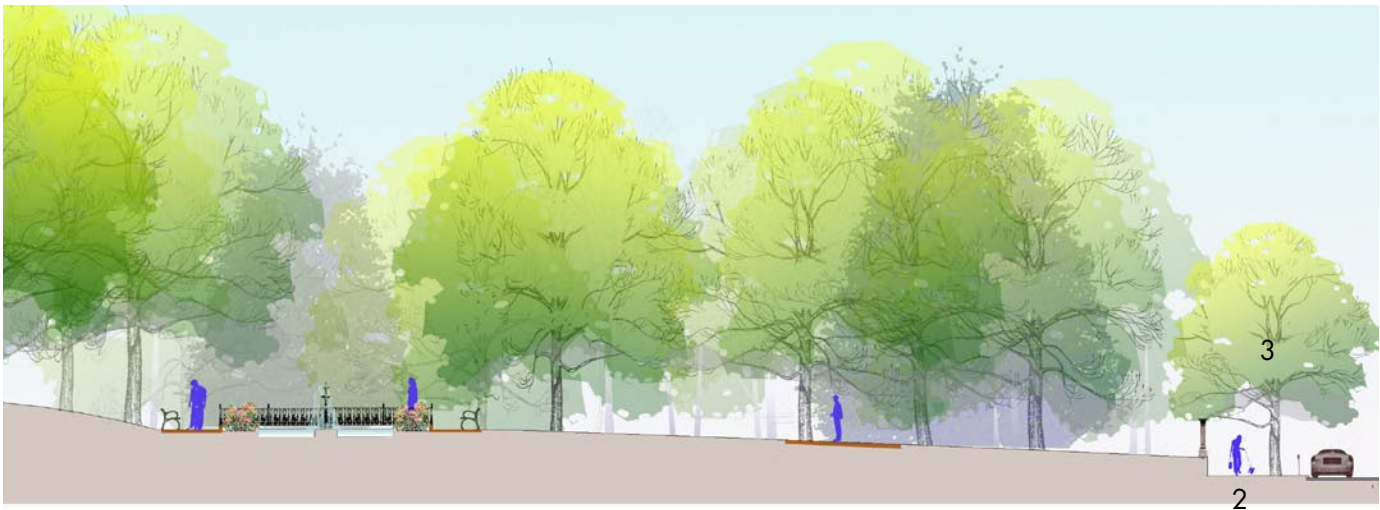
*Cross Section at Bank Street - Proposed Improvements*

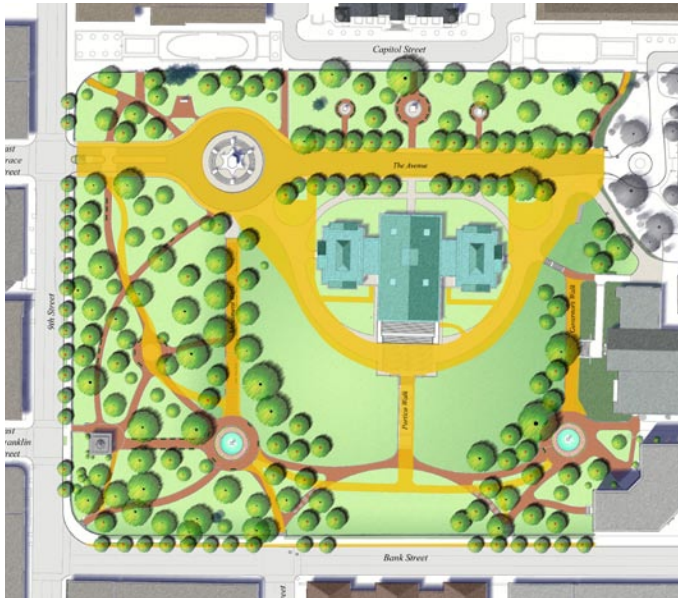
*Area of existing paving to be modified*

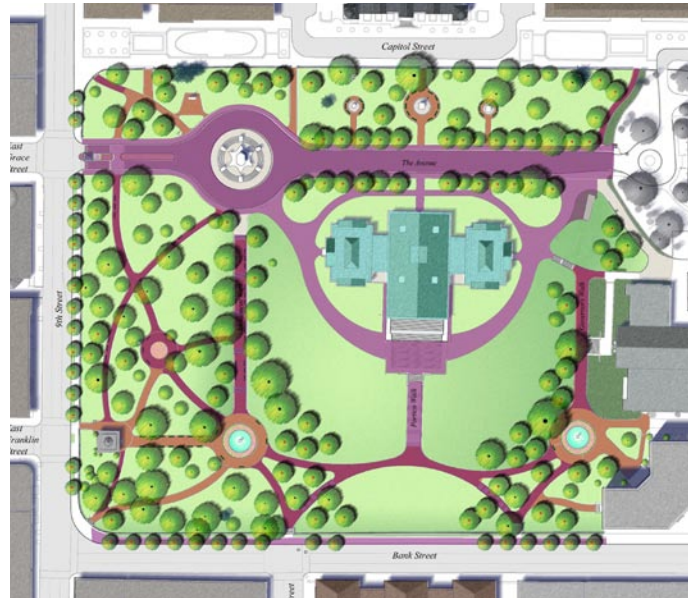
*Modified areas of paving*

The shaded portions in the diagram on the right represent the areas where new paving is being recommended. In some areas, the material is changed in order to make it more consistent with historic materials. In other cases, only the alignment or grade changes.

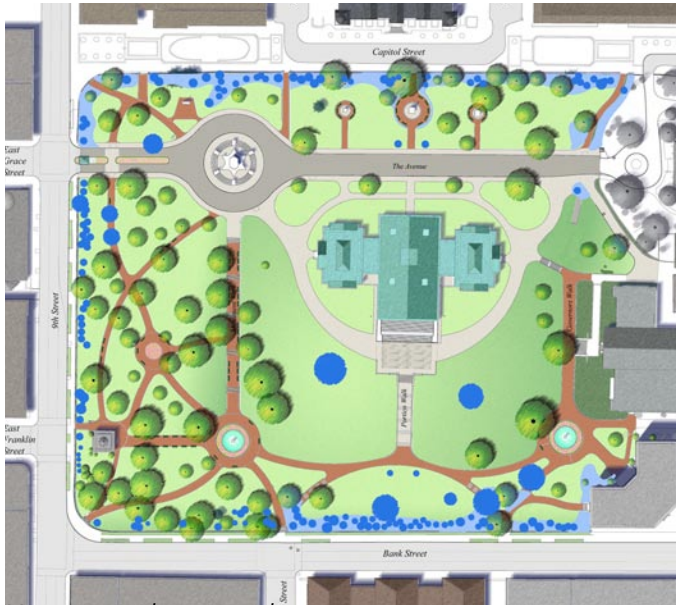
*Vegetation to be removed*

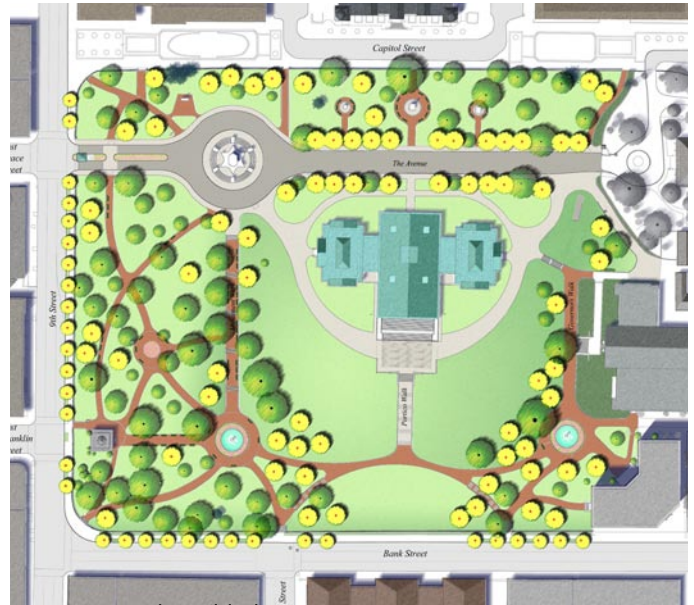
*Vegetation to be added*

The diagram on the right highlights new trees to be planted under the Landscape Master Plan. Some are aligned in formal rows to replicate historic allees or street trees. Others are more loosely arranged to blend with the existing informal groves.
